사전제작형 콘크리트궤도의 충전층 상태에 따른 열차하중 거동 실험적 분석

Field Experimental Analysis of Precast Concrete Slab Track Behavior under Train Loads Depending on Grouting Layer Conditions

Abstract This study was conducted to analyze experimentally in the field the behaviors of the precast concrete slab track (PST) under train loads depending on grouting layer conditions. The vertical accelerations, vertical displacements, and relative displacements between slab and grouting layer were measured to investigate the behaviors of the PST according to the existence of a gap between slab and grouting layer and the completion of the grouting layer repairing. The results showed that the vertical displacements of the slab were very comparable between the slabs with and without a gap at the interface to the grouting layer, and those were very small for the slabs with the grouting layer repaired.

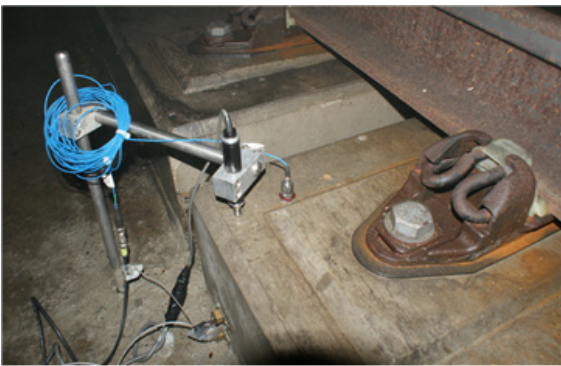
Fig. 1 Gauge installation

충전층 상태에 따른 실험 위하여 우선 두 종류의 슬래브에서 실험을 수행하였다. 1번 슬래브는 충전층과 슬래브의 간극은 발생하였지만 보수가 시행되지 않은 슬래브이며, 2번 슬래브는 충전층에 간극이 발생하여 그라우팅 주입을 하고 모서리부 탈락으로 인한 보수가 시행된 슬래브이다. 실험을 위하여 Fig. 1과 같이 동적 거동 측정을 위한 센서를 설치하였다.

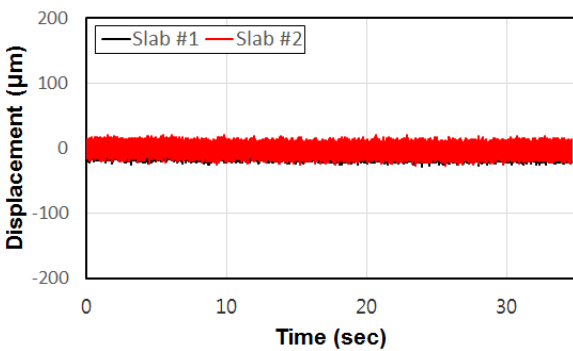
Fig. 3 Relative displacements between slab and grouting layer

Fig. 2 는 열차하중에 의해 슬래브에 발생하는 수직 변위를 나타낸 것으로 1번 슬래브에서 열차하중에 의해 발생하는 수직변위가 2번 슬래브에 비해 크게 발생하는 것으로 나타났다. Fig. 3은 슬래브와 충전층의 간극을 비교한 것으로 두 슬래브 모두 열차하중에 의해 간극의 변화는 크지 않음을 알 수 있다. Fig. 4는 수직가속도를 측정한 것으로 1번 슬래브가 2번 슬래브에 비해 더 큰 가속도가 측정되었다.

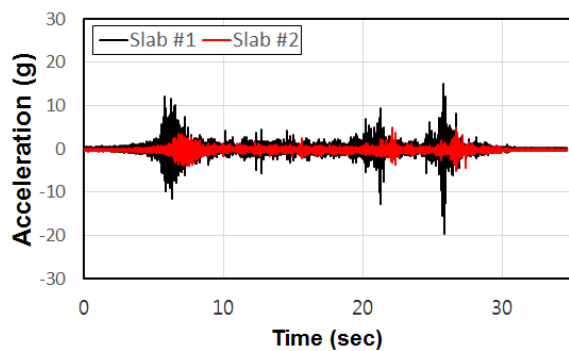
Fig. 4 Accelerations
